# CHARLOTTE

Requested by: Biscayne Landing HOA	Date: December 18, 2024	ID#: 11074
---------------------------------------	----------------------------	---------------

Subject: 1" PVC schedule 40 pressure elbow evaluation

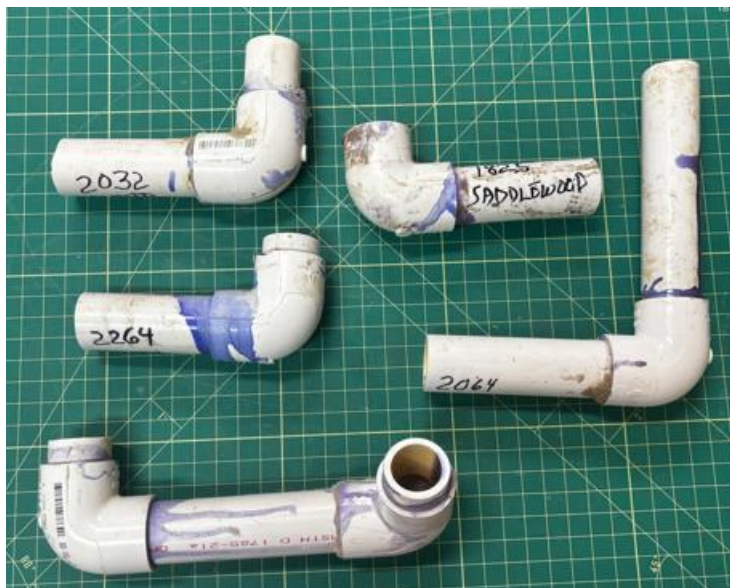
Figure 1

On December 2, 2024, Charlotte Pipe and Foundry ("CPF") received five 1" PVC schedule 40 pressure elbow assemblies to examine with a total of six elbows (figure 1). The assemblies were installed underground outside of multiple residences. Five of the six elbow fittings have cracked causing leaks to occur with homeowners experiencing higher than normal water bills. CPF has been asked to determine why the fittings have failed.

The six 1" PVC schedule 40 pressure elbows were produced from mold #31-1079 and we could only identify four cavities (C, D, HH, and K). Each assembly is solvent welded to pipe using a purple primer and clear cement. Five of the six elbows have similar cracks running across the back. Sand and debris were visible inside the cracks.

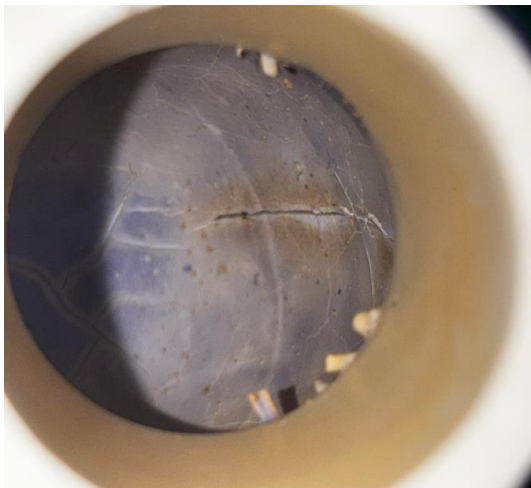
Figure 2

Observed in all six elbows were either excessive puddled cement, puddled primer, or a combination of the two (figures 2-3). Figure 4 shows puddled primer in the pipe of one assembly. This puddling penetrated into the pipe wall.

No manufacturing defects were observed in any of the CPF 1" PVC schedule 40 pressure elbows. The leak locations (cracks) correspond with areas of excess solvent cement and primer, which can induce environmental stress cracking ("ESC") in PVC systems. Solvent cement and primers are routinely used during the installation of PVC piping systems and permanently join components together. When too liberally applied, the excess inhibits complete and efficient evaporation of active solvent.
